## HANGAR FLOOR SETTLEMENTS AT THULE AIR BASE, GREENLAND

TECHNICAL REPORT NO. AFWL-TR-69-122

March 1970

AIR FORCE WEAPONS LABORATORY  
Air Force Systems Command  
Kirtland Air Force Base  
New Mexico

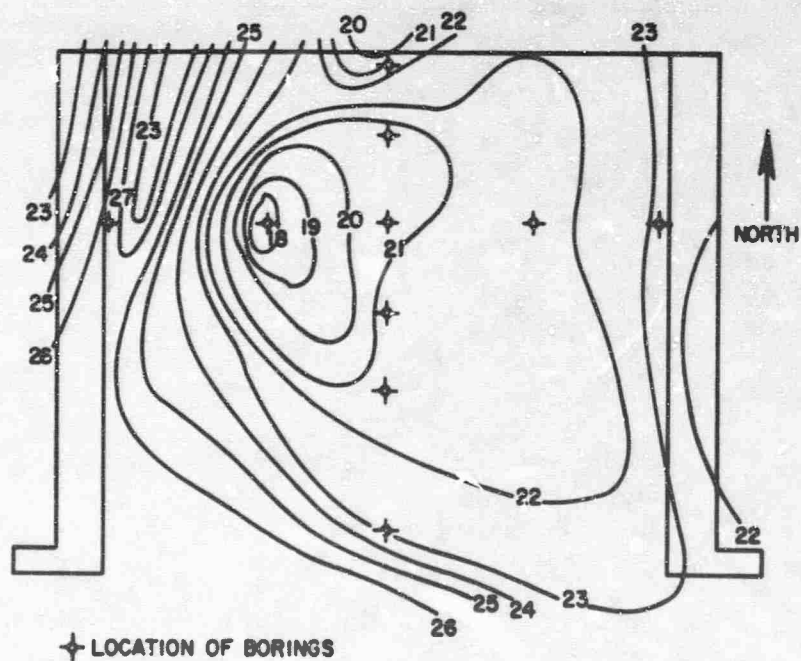
Figure 9. Distance in Feet from Finished Floor to Native Soil below Hangar 10 as Found from Soil Borings in 1953

In 1953 numerous holes were drilled through the floor of hangar 10 and into the soil below for installation of thermocouples. The soil boring logs were reviewed and a map produced showing the distance from the hangar floor to the native soil (figure 9). Boring logs indicate that the upper 6 to 24 inches of native soil generally contains little ice and probably would not produce noticeable floor settlement upon thawing. Nevertheless, the thaw danger line has been assumed as the upper boundary of the native soil.

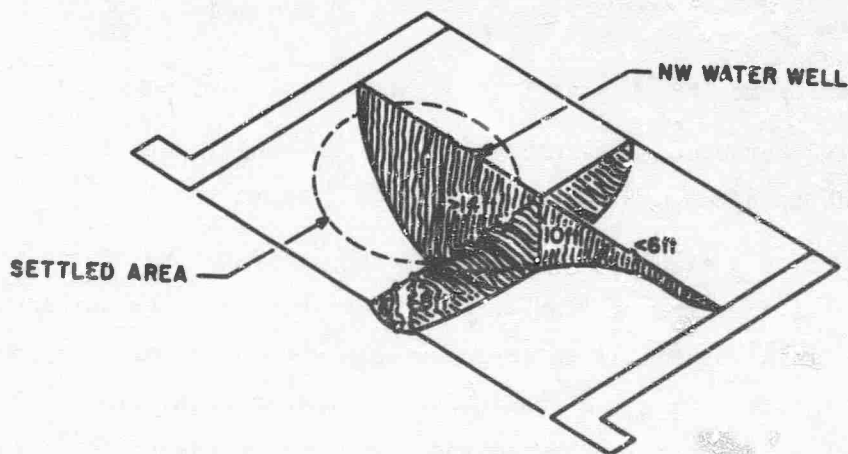
Figure 11. Location of 0°C Isotherm below Hangar 1, January 1969

Temperature profiles as measured on 9 January for the five thermocouple assemblies in hangar 1 are shown in figure 10. They indicate that the 0°C (32°F) isotherm has penetrated to a depth exceeding 14 feet below the area of maximum floor settlement as shown in figure 11. It appears that localized deep thaw penetration has caused the settlement. The information in table II suggests that several feet of native soil have been thawed. It is important to note that the maximum depth of thaw closely coincides with the location of the well from which ground water has been pumped from under the hangar.

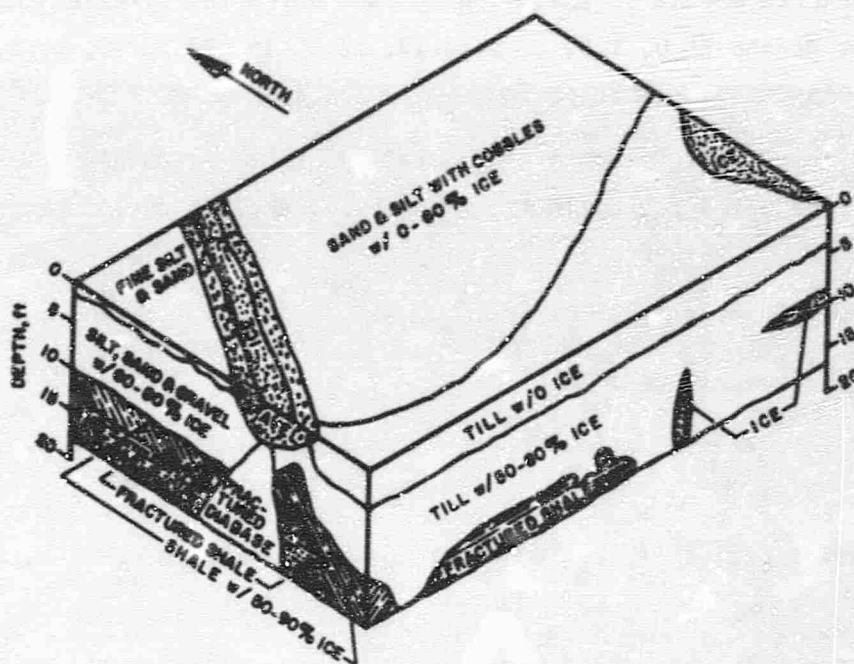
Figure 21. Isometric View of Native Soil below Hangar 10

An isometric sketch of the soil conditions below hangar 10, based on visual examination of the side of the excavation made when installing piles, is shown in figure 21. The complicated nonhomogeneous soil system and isolated wedges of ice indicate that an extensive subsurface exploration program would be required to clearly delineate soil and ice boundaries within the native material. It is felt that the cost of a comprehensive soil investigation program would far outweigh any design refinements that might result from the additional information collected. However, a few checks of the depth to native soil would be helpful for corrective purposes and additional subsurface temperature information is desirable for more effective monitoring of the performance of hangars 1 through 9 once modifications are made.
